Assessing asphalt

Asphalt roof systems remain significant players in the industry

by Todd Ziem

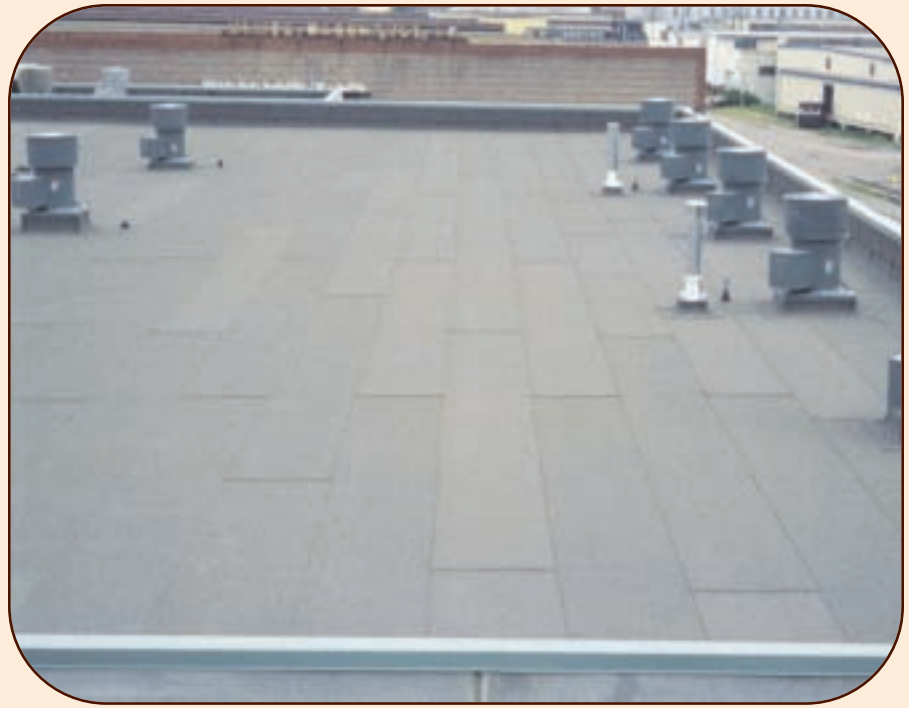
For this roof system, the base sheet and ply sheets, as well as the modified bitumen cap sheet, were applied in hot asphalt. Photo courtesy of CertainTeed Corp., Valley Forge, Pa.

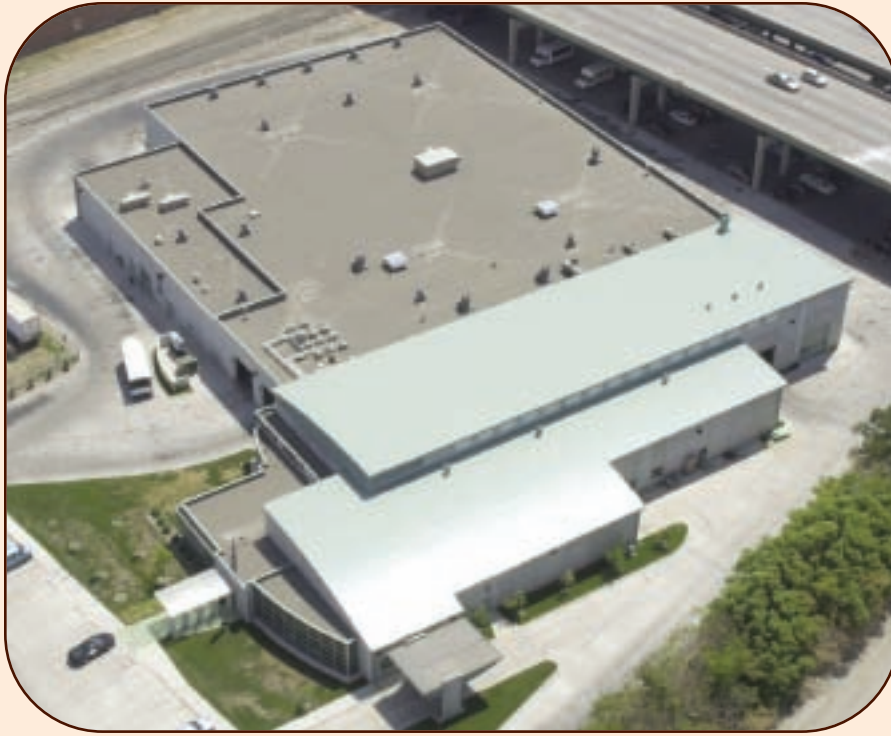
The Wichita Transit System facility houses buses and vans, as well as administrative offices. A gray color was used to enhance the appearance of the cap sheet because this facility is visible from a nearby highway that passes above it. Photo courtesy of CertainTeed Corp., Valley Forge, Pa.

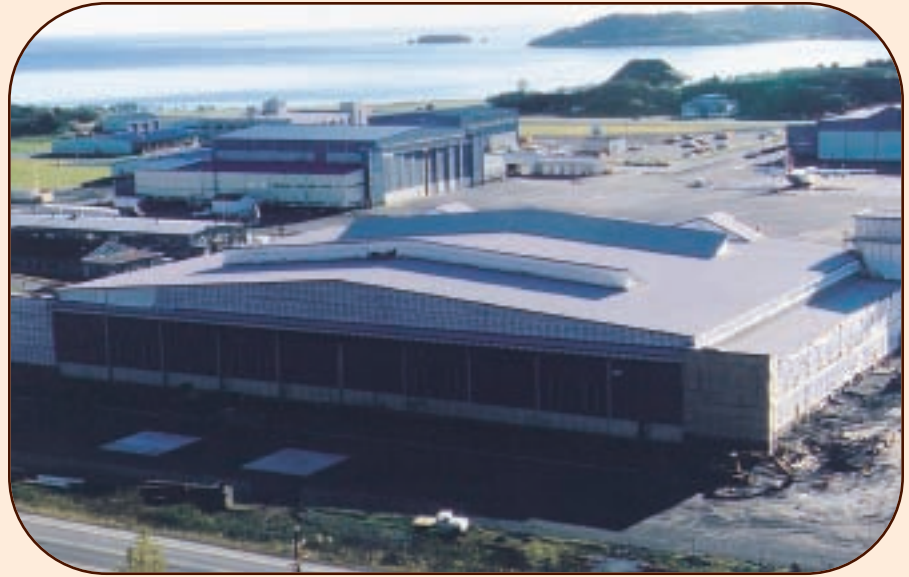
Winds of 50 mph to 100 mph are common at the Coast Guard Naval Air Station on Kodiak Island, Alaska. This facility was used to house fighter planes in the 1940s and now houses Coast Guard airplanes and helicopters. Two historic hangars with a total area of 1,480 squares are covered with a smooth-surfaced APP-modified bitumen roof membrane capped with a mineral-surfaced APP-modified bitumen cap sheet. The membranes were torch-applied. Photo courtesy of CertainTeed Corp., Valley Forge, Pa.
