Roof Gravel – Control by Design

By Michael D. Fischer, Director of Codes and Regulatory Compliance – Asphalt Roofing Manufacturers Association

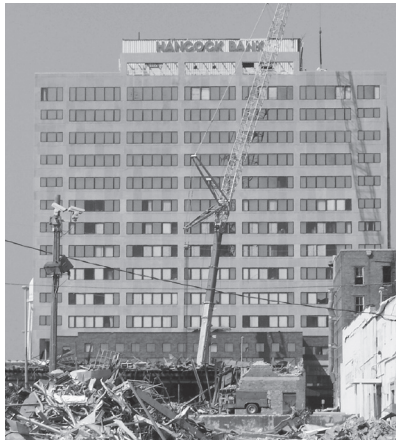
Figure 1 – Hancock Bank Building, Gulfport, MS after Hurricane Katrina

The Hancock Bank Building (fig. 1) shows a classic pattern. Broken glass along much of the lower portions of the building is a clear indication of windborne debris damage. Since wind pressures acting on the building were likely greater at the higher floors, we would expect wind load failures to occur farther from grade. The higher floors do show some glass damage; this might have been caused by wind vortices that lifted debris and sent it over the side of the building façade, where it was then in a position to impact the glazing elements. The Hancock Bank Building was built before windborne debris requirements were part of the Mississippi building code.

The contrast between the performances of these two buildings is significant. Changes in structural design, opening protection, and installation methods, as well as code enforcement and inspection, account for the minimal damage to the Island View while less than one mile away, the Hancock Building suffered devastating damage.

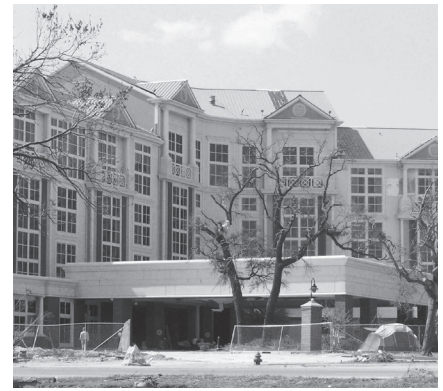
Figure 2 – Island View Casino and Resort, Gulfport, MS after Hurricane Katrina

Resort (Fig. 2) includes laminated glazing that meets missile impact test requirements. Despite the presence of nearby, older structures that provided a source of windborne debris – including roof gravel – there was comparatively little glazing damage to the Island View.
